## INJECTION MOLDED PART MATERIAL FAILURE ANALYSIS

Nicolae SOLOMON<sup>a,\*</sup> and Iulia SOLOMON<sup>b</sup>

<sup>a</sup>“Stefan cel Mare” Suceava University, Str. Universitatii nr.13, 720229 Suceava, Roumania

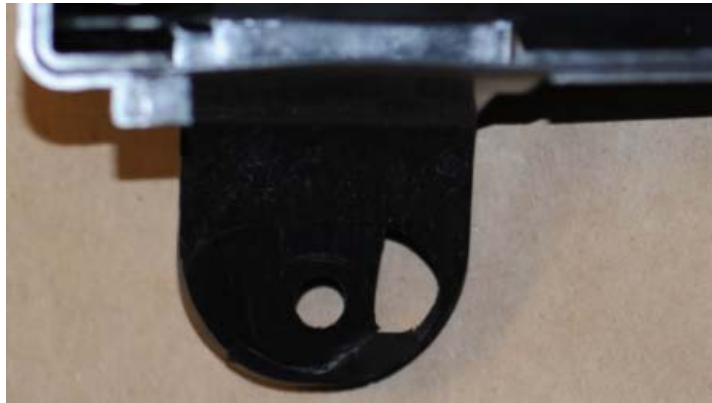
At first, we investigated a defective molded polyamide clamshell part, used in automotive industry to determine the reason for crack failure (Figure 1). It was reported that the crack failure had developed while the molded part was merged to the mounting pin (Figure 2). Reference material was provided to run comparative analysis. According to the customer statement, some molded parts were found to be warped, difficult to install them onto assembly: “several clamshell parts could not be assembled in the accumulator assembly because they were not flat.” Afterward, other 2 defected molded parts and resin beads of Nylon 6 were sent for fracture failure analysis. Nylon 6 (PA6) main characteristics are presented in Table 1. The suspect production began failing with 2 parts/shift and reached a peak of an average 1 failure per hour and during a week a total of 88 broken brackets, before the process to be stabilized.

Fig. 1 – Defective part because of crack failure.

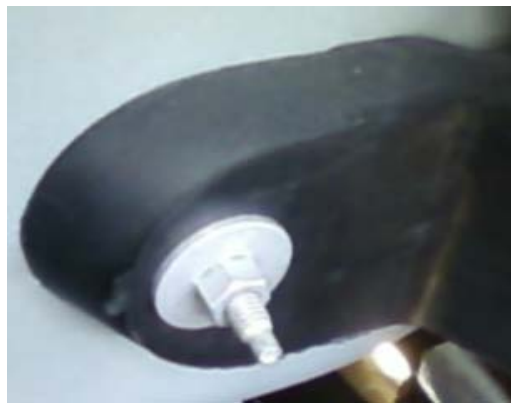
Fig. 2 – Bracket – pin assembly.

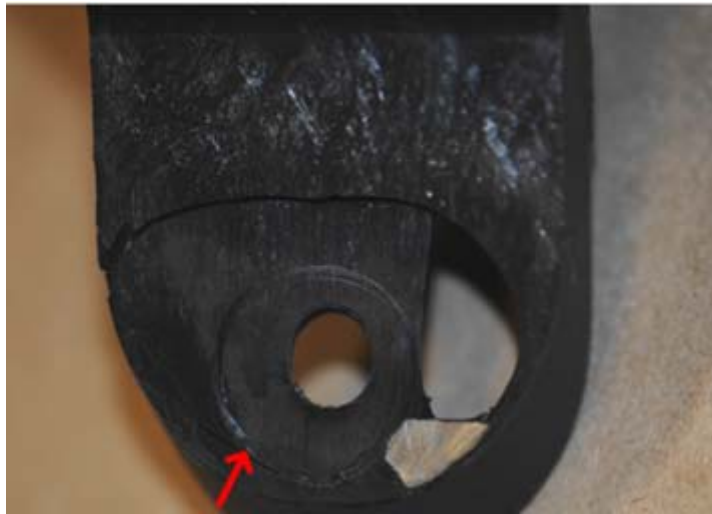
received samples for fracture failure analysis is shown in Figure 3. It presents fractures along one of its legs. It was noted that a section of the fractured leg was missing and a circular indentation on the exterior surface of the leg was also visible (Figure 3). It can be also seen that the washer indentation was on the entire leg surface. It shows that the pin of the assembled part was not centered to the hole, when it was installed on the bracket. Further examination of the sample disclosed the presence of what appeared to be a flow pattern along the exterior surface of the legs. The typical appearance of this condition is shown in Figure 4. Visual examination of the bracket fractured surfaces revealed a faceted fracture surface, with no significant whitish discoloration or deformation, which is consistent with a brittle material overload. Additionally, the presence of a mirror zone and rib marks were also detected. The mirror zones are flat, featureless regions that surround the fracture origin in plastic failures. It was noted that the mirror zone appears to be primarily along the exterior surface. Microscopic examination of the fractured region disclosed the presence of secondary cracks connected to the main fracture. This feature is shown in Figure 5. The map of the fracture indicates a relative material ductility, as a function of temperature and strain rate, for a relatively severe stress state [12, 13]. A cross section (perpendicular to the observed flow lines) was removed and polished for examination. Thus, microscopic examination showed that the flow lines appeared to be relatively shallow and did not penetrate deep into the cross section. This aspect is shown in Figure 6. All cracks appear to be initiated from the washer indentation of the mating pin, which was installed on molded polyamide clamshell part, and propagated outward. The fracture of the broken area exhibits a grainy, irregular tarring texture. The broken area (Figures 1 and 3) presents characteristics of a brittle fracture, which has a little or no plastic deformation prior to fail. Due to molecular degradation during molding process, the material of the part was significantly embrittled because of molecular degradation, and consequently, a brittle fracture occurred during pin assembly. Specimens from broken part, resin beads and from a good-quality molded part were analyzed using FTIR spectroscopy.

Fig. 3 – Defective part - circular indentation (severe tool marks).

A circular indentation was noted around the mounting hole, suggesting a tightened washer/nut. This detail indicated that the part had failed due to

over tightening during the assembly operation. The fracture had initiated at the exterior surface of the leg, near the mounting hole. This would indicate that the failure was because a one-time load exceeded the strength of the material.

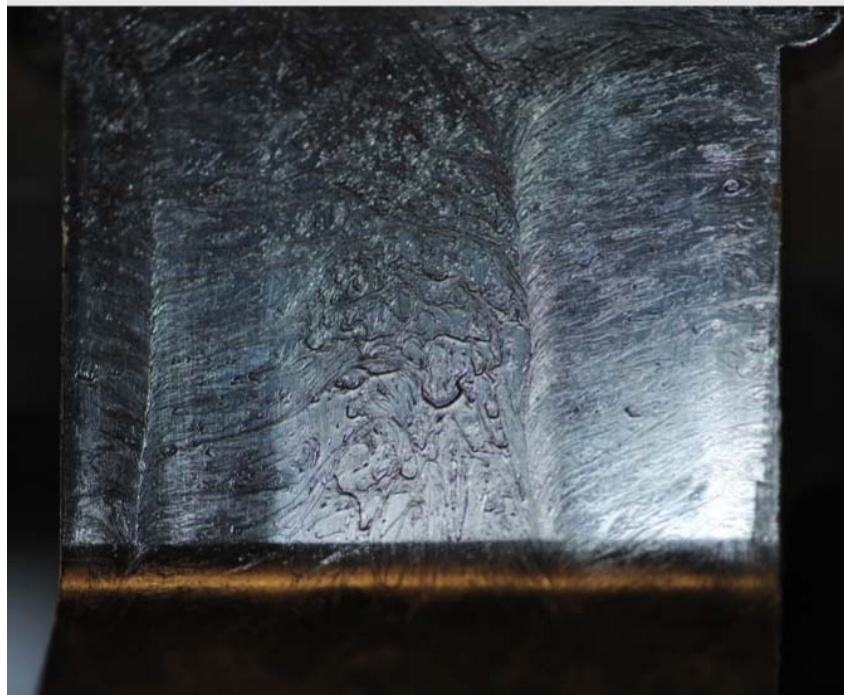
Fig. 4 – Flow pattern along the exterior surface of the leg.

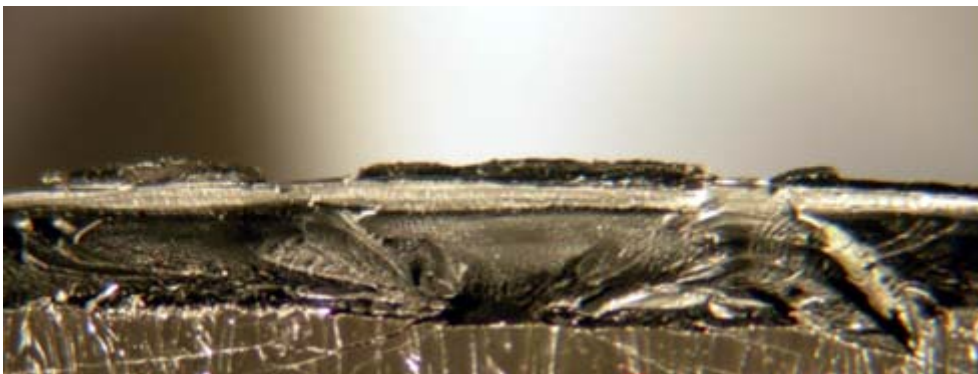
Fig. 5 – Secondary cracks connected to the main fracture.

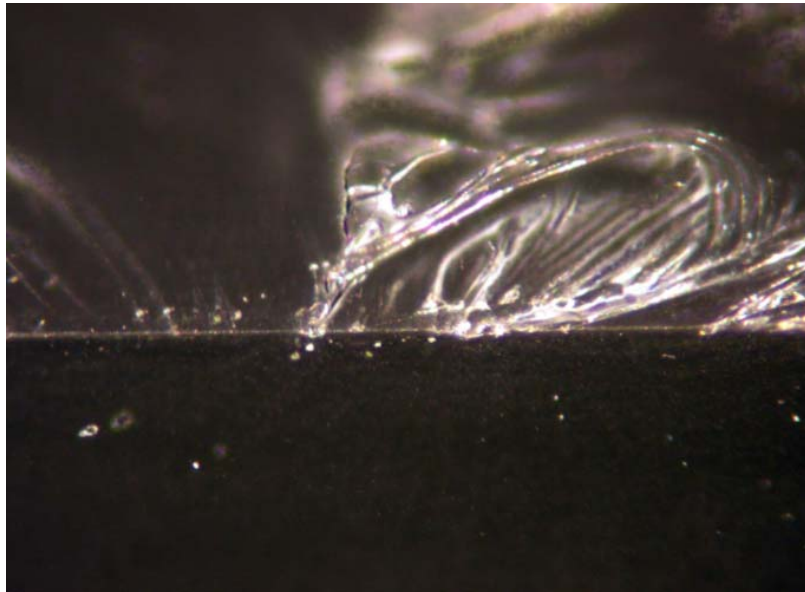
Fig. 6 – Cross section - flow lines.

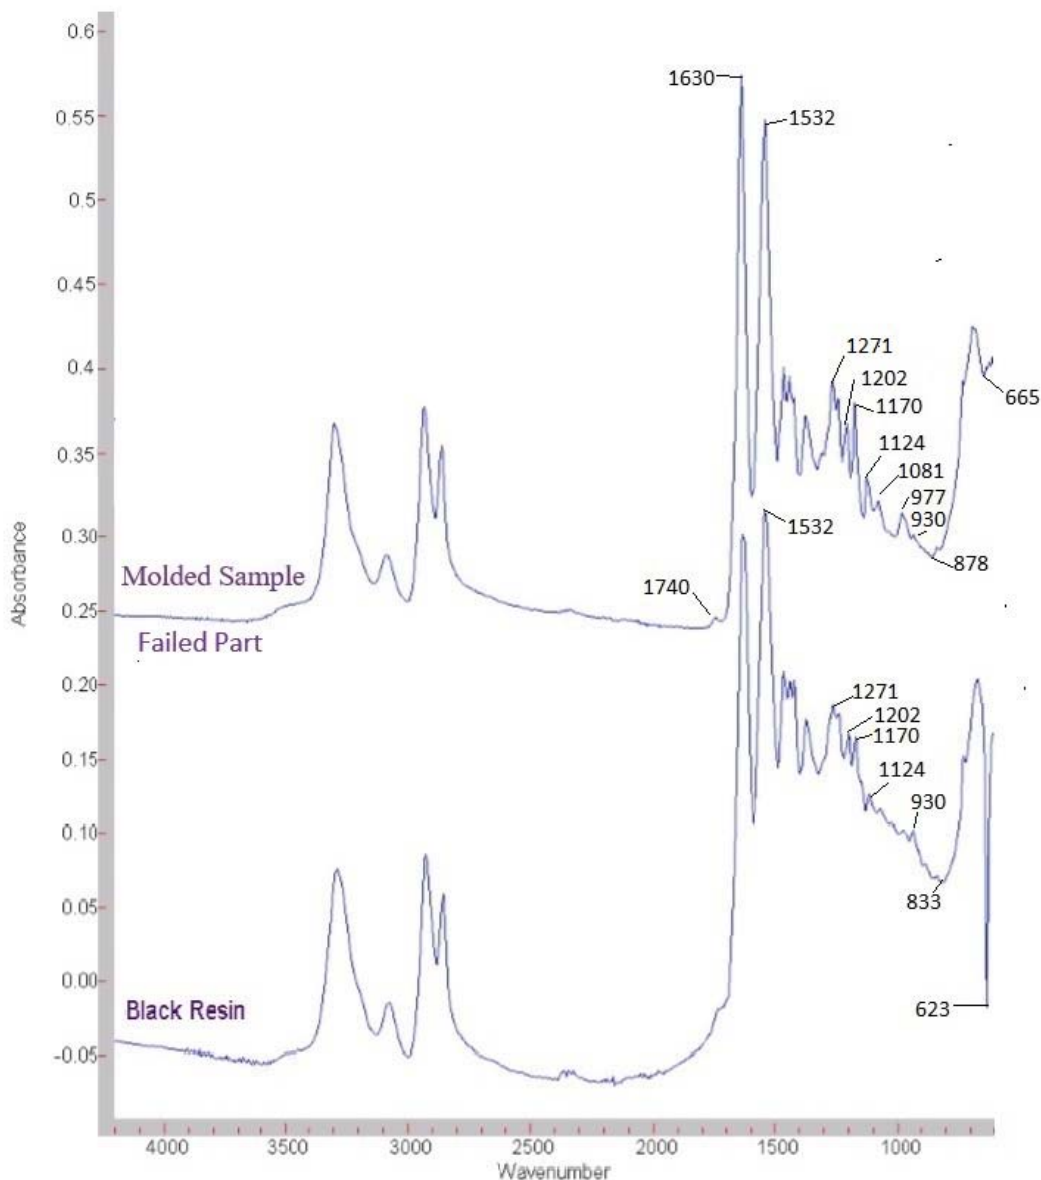
In addition to the absorption bands at 977 and 1274  $\text{cm}^{-1}$ , the spectra obtained on the failed parts show a vibration band at approximately 1740  $\text{cm}^{-1}$  which indicates a partial oxidative degradation of the resin. The oxidation/degradation phase can be the cause of part shrinkage, which generates internal tensile stress with direct consequences in the occurrence of microcracks and, eventually, of part failure. As the analyzed part has never been in service, the aforementioned material degradation took place only during molding process.

Fig. 7 – FTIR spectra of the reference sample, black resin (bottom) and the failed molded part (top).

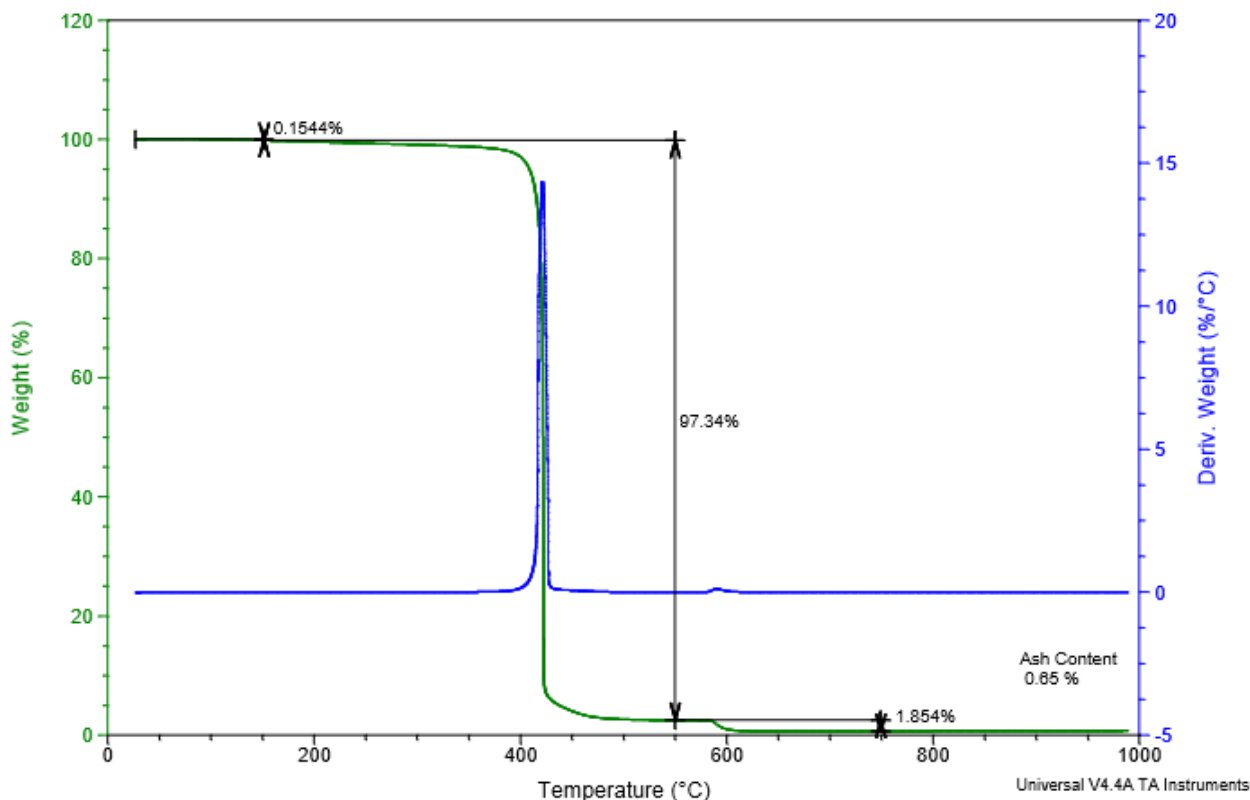
Fig. 8 – TGA thermogram (green) and its 1st derivative (blue) for an investigated sample.

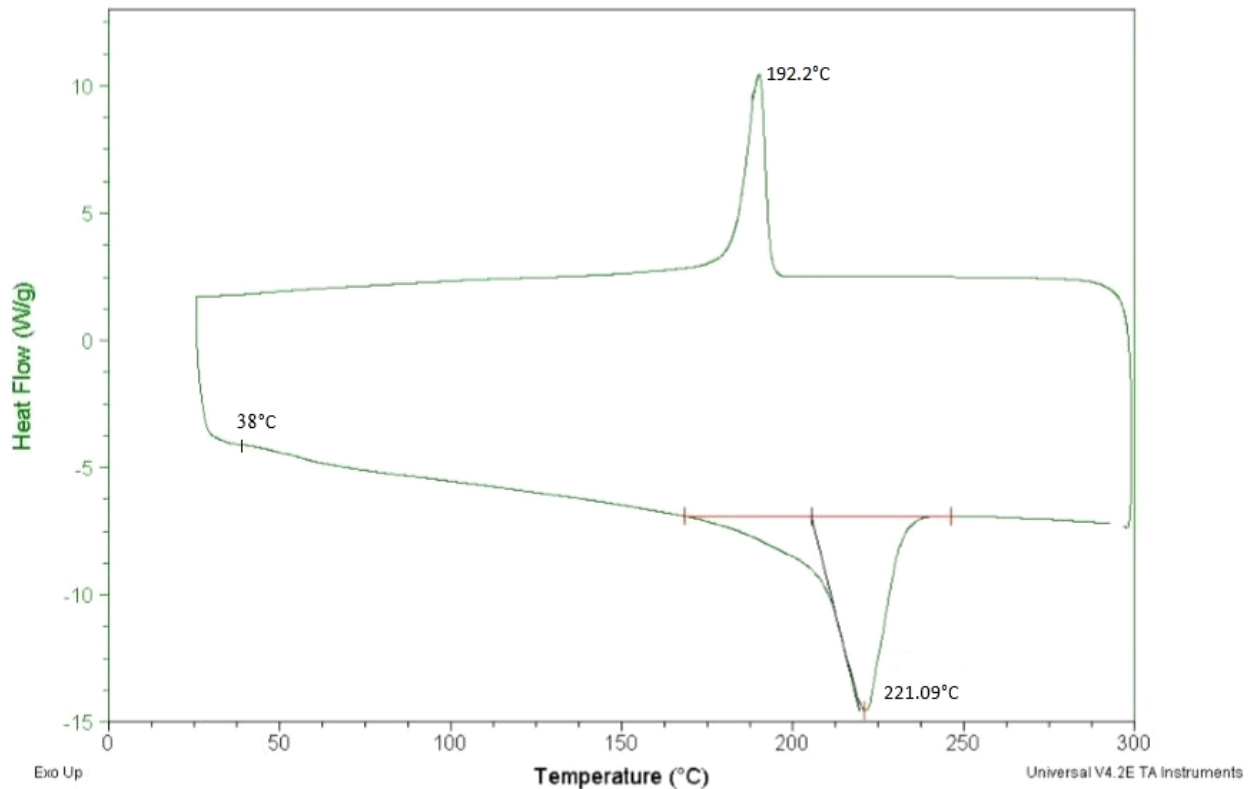
with a single polymer component described by a unique melting transition (peak temperature of 221.1°C, the value consistent with that for Nylon 6 - Table 3). Practically, the peak temperature at about 221°C is characteristic to the alpha phase and was found for each tested material.

Fig. 9 – DSC thermogram for an investigated sample.

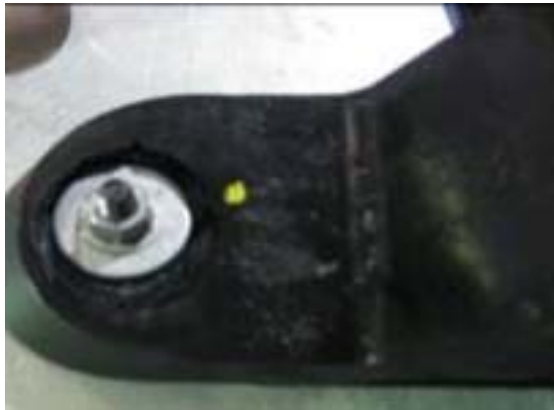
Fig. 10 – Parts after torque test: a) broken bracket; b) good bracket.

(a) In the case of suspect lot, a test with a wrench of 8 Nm torque 473 was performed using a 1000 RPM pneumatic gun. There were no broken brackets for using 3.0 Nm torque. However, the torque study revealed that 5 of 6 parts from the suspect lot broke between 3.0 and 8 Nm. The bracket fracture surfaces has exhibited brittle characteristics (Figure 10).

In both situations (Nylon 6; austenitic stainless steel), under an applied pressure, the material of the part became harder and then less resistant to external physical (corrosion) or mechanical action (torque test). Due to material hardening, as a result of  $\gamma$  to  $\alpha$  phase transition, austenitic stainless steel became less corrosion resistant<sup>5</sup> (Figure 11) and the molded polyamide also became more brittle and susceptible to break (Figure 10 a).

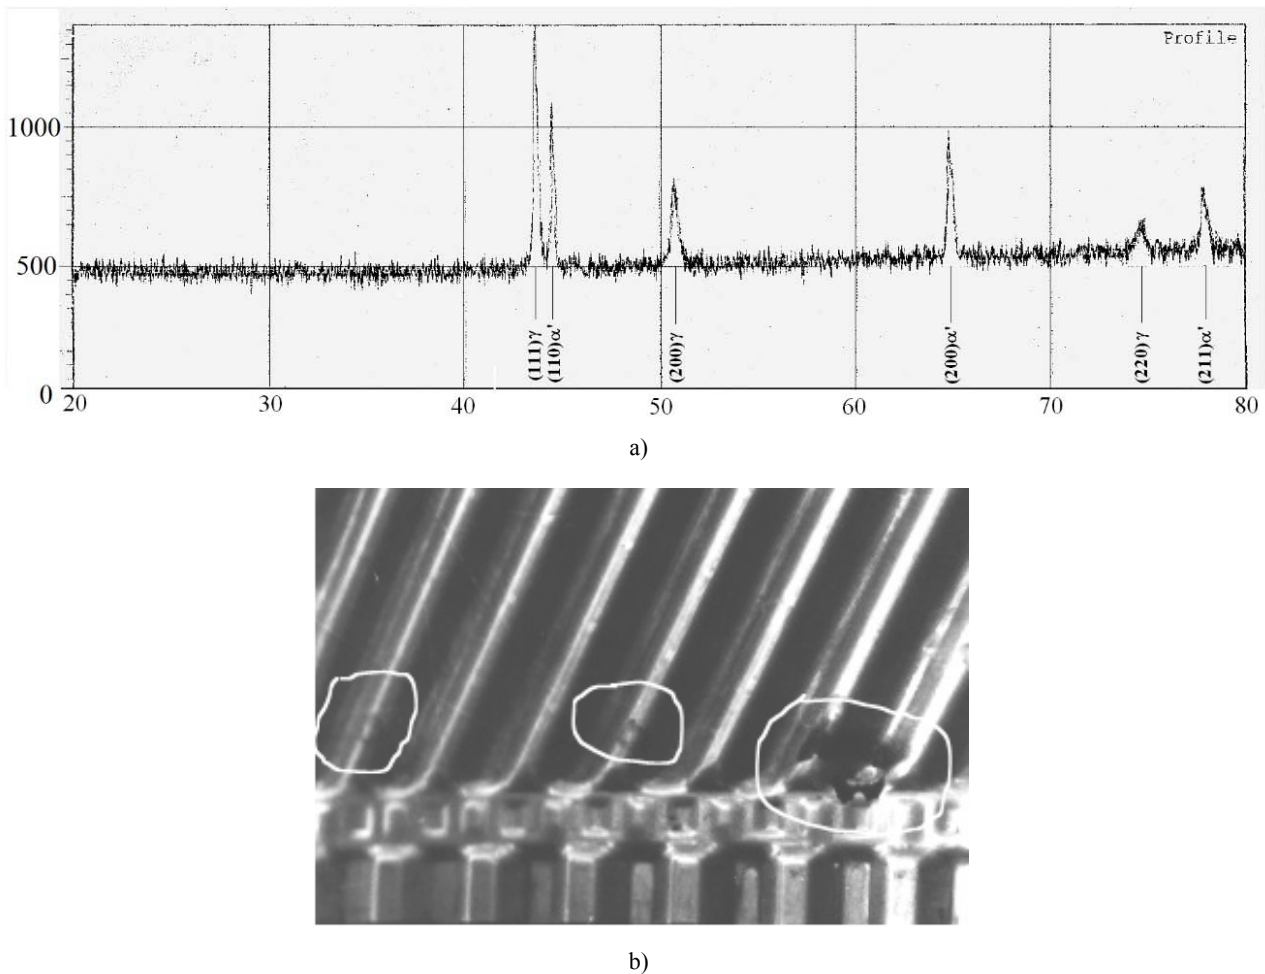
Fig. 11 – Austenitic Stainless steel: a) X-ray diffraction pattern after plastic cold deformation; b) Pitting corrosion.
